Why do ES581.4 errors occur during hardware initialisation or flashing?

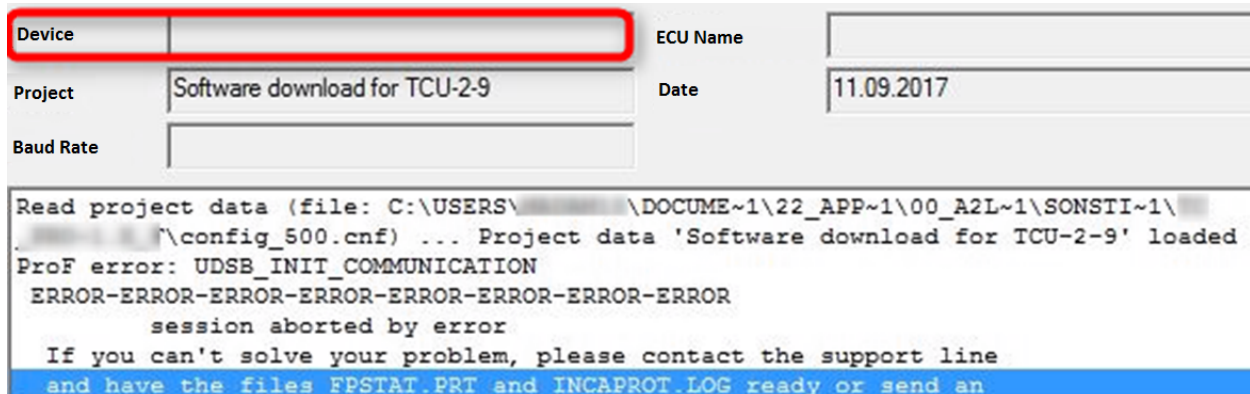
This is due to an incompatible version of the ES581 USB driver and/or an incompatible firmware version of ES581.4.

After the initialisation of the hardware the EPROM Identifier is not displayed correctly in the Memory Page Management window.

If the ECU is flashed using ES581.4 the following error pops up:

- Unplug ES581.4 from the USB port
- Uninstall the old driver of ES581.4  
Control Panel -> Programs > Programs and Features => ES581.4 USB-CAN-Driver
- Install Hardware Service Pack [HSP 11.5.1](#) (or higher)
- Launch the HSP Update Tool and install the new ES581.4 Driver: menu "Drivers" => ES581.4
- Re-connect ES581.4 to the USB port  
Wait for the Windows confirmation that new hardware was found and can be used

- Run "Search for Hardware" in the HSP Tool
- Run the ES581.4 firmware update from HSP tool, if required
