## Question:

Initialization 또는 Flash 중에 발생하는 ES581.4 는 어떻게 해결해야 하나요?

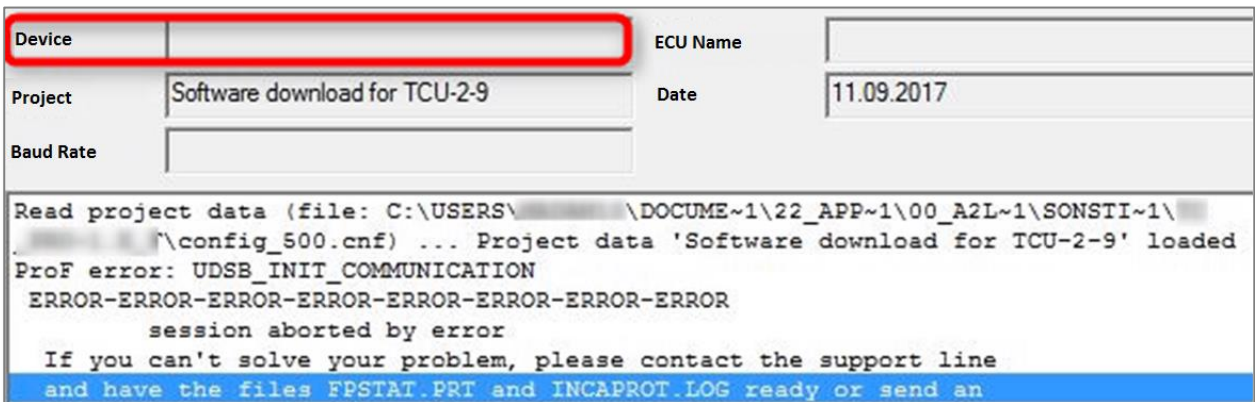
ES581.4 를 Initializing 후, 메모리 페이지에서 EPROM identifier 가 출력되지 않거나, ES581.4 로 flash 시도 중에 아래와 같은 에러 메시지(ProF error)가 출력되는 경우가 있습니다.

이 문제를 해결하기 위해서는,아래 내용들을 확인해 보시기 바랍니다.

- USB 포트에서 ES581.4 를 제거하고,
- ES581.4 드라이버를 제어판에서 제거 (Driver Uninstallation)

\*제어판 >> 프로그램 및 기능 >> ES581.4 USB-CAN 드라이버 선택 제거

- 최신 HSP(최소 11.15.1 또는 그 보다 상위 버전)를 설치
- HSP update tool 을 실행하여 ES581.4 드라이버 설치  
\*메뉴, 드라이버 >> ES581.4
- USB 포트에 ES581.4 를 다시 인가  
\*Win OS 에서, "새 하드웨어 설치" 및 "사용할 준비가 되었습니다". 메시지 확인 후,
- HSP update tool 에서 장치 검색 ("Search for Hardware")
- 장치 펌웨어 업데이트 (Firmware update, 필요 시)
